# MUNICIPAL BUILDING: ABERDEEN, SD

SPACE QUEST & PUBLIC SERVICE, 1911-1996

#### MUNICIPAL BUILDING: ABERDEEN, SD SPACE QUEST AND PUBLIC SERVICE, 1911-1996

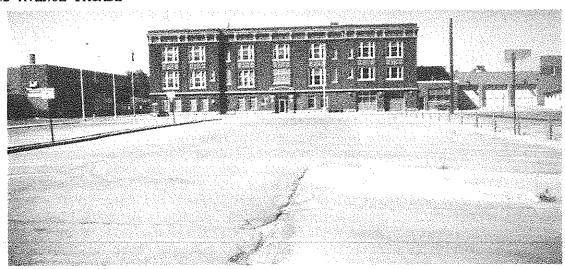
#### SECOND AVENUE FACADE

A major feature of the Second Avenue facade is its geometric, rectangular, three-storied form which seemingly occupies a lengthy swath of land but in reality the axial facade is only 134 feet. The brick exterior creates an impression of solidity. The numerous window bays of the 2nd and 3rd floors, the decorative concrete belt courses between 1st and 2nd floors and below the roof line add to the horizontal effect. The upper belt course protrudes out over the design bands and is supported by concrete corbels or brackets. Above the larger belt course is a foot-long brick wall on top of which is a thinner belt course. A short brick strip points upward from the stone foundation to below the first floor windows and stretches west-to-east across the entire structure. This contributes, along with the stone foundation, to the horizontal image. Upon closer examination that facade has a recessed central section joined by a projecting west end and east end. The central section is recessed 2 feet from surrounding segments. As window dividers, 9 vertical brick strips of varied widths stretch upward to the belt courses adding a vertical dimension.

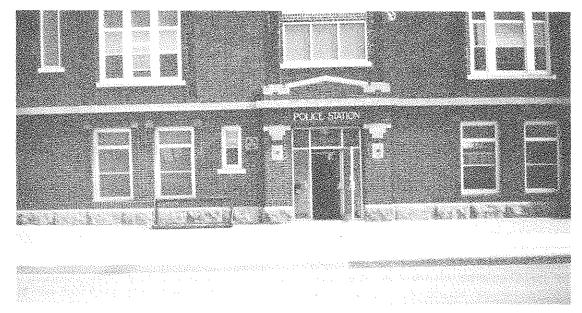
The central pedestrian entryway, marked Police Station, has a concrete triangular pediment above the door. On each side of the entry on the upper brick background is a concrete design—an abbreviated column about 1 foot long in the form of a"T". This pediment and column is suggestive of neo classical revival architectural style except its columns are not as large and impressive as those associated with the ancient Greeks. There is an element of Renaissance Revival and Chicago Commercial Style in the building's formalism, symmetrical shape, belt and string courses, flat roof, and pedimented doors on both 2nd avenue and Lincoln street. Evidence of window alterations appear immediately above the central entryway with one window bay completely paneled and the upper panes on all windows also paneled. This suggests that the original windows of 1913 were longer and shorter windows replaced them. Lower interior ceilings may be a factor in window alterations.

On the east side of the Police Station door are 2 windows with 2 concrete squares on their upper corners. Further east is the fire station segment with its 2 large doors on the 1st floor. Light globes adorn the brick columns on each side of the doors. The door on the extreme east—end opens for automobile usage, but the renovated door to the west now conceals police office space. Fire engines since 1982 have used the garages further east of the municipal building.

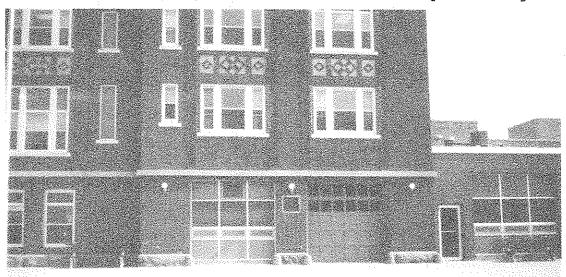
The design pattern between windows of the 2nd and 3rd floors and in the belt course just below the roof add variety and attract the eye. Above the 2nd floor windows are 7 groupings of design units each with 3 geometric designs. Two design units are in the projected segments at both the west and east ends of the building and 3 are visible in the central recessed segment. The common geometric form used on the 2nd avenue facade was an X or a cross encased within a diamond which is sandwiched in between two plain diamond shapes.

On the belt course above the 3rd floor windows and below the roof stretch 17 design units, 7 of which are located on the central recessed section of the building. The east-end design and the one between east-end windows is a single diamond surrounded by 2 brackets with recessed squares at the lower end of the corbel. Above the 2 window bays is a design of 2 single diamonds surrounding a central circle containing a cross with a small diamond at the intersections of the cross lines. In the central recessed segment 3 X's and 4 crosses alternate as the circle's centerpiece. Over the Fire Department segment's are 5 design units. Single diamonds adorn each end. One diamond in the center separates 2 units containing 3 geometric forms, which are crosses surrounded by single diamonds. The red brick symbols rest on a stucco background.

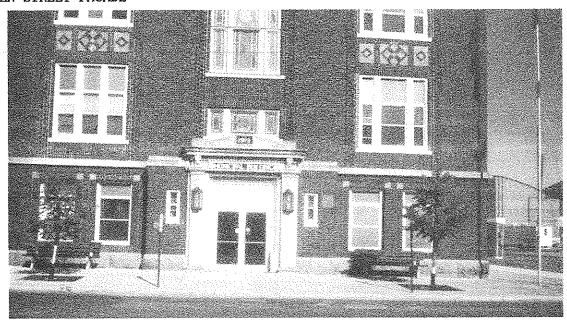
#### LINCOLN STREET FACADE

The Lincoln Street facade focuses on the central entryway with 2 sidelight windows immediately astride that doorway and 2 stained glass windows looming up above that entry toward the roof line. Above the entryway pediment a 3 paned, stained glass window stretches north to south. Further up looms a larger stained glass window with 9 dimensions or lights. A giant "A" for Aberdeen draws attention to the middle pane. Immediately below the pediment concrete columns containing globes for night lighting frame the entryway. A triangular pediment rests above the doorway with date of construction embossed below. Above the entryway and below the pediment appear the words: Municipal Building. Two double sash windows rest north of the central entry and another 2 windows south of the doorway provide balance to that facade. Panels block the upper portion of the windows indicating a past window change to shorter windows. Two design patterns emerge above the 2nd story window opposite the central stained glass windows. Two single diamonds surround a circle with an X in the center.

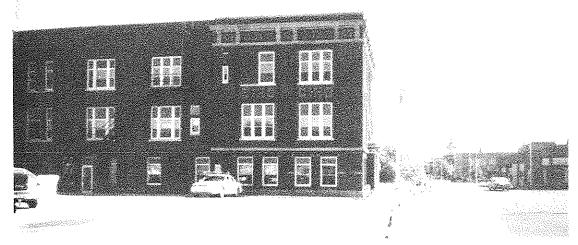
#### NORTH OR FIRST AVENUE FACADE

From the north corner of the Lincoln Street facade a belt course continues eastward to separate the 1st and 2nd floors to the point where the recessed section begins. Below this concrete belt are 4 elongated rectangular windows with 6 glass panes and one upper section of 3 panes blocked with panels. The central section recesses about 2 feet from the western section.

Two windows lighten the finance offices. West of the rear exit door is an elongated block glass window providing privacy for the north wall men's bathroom. The parking lot door or rear exit to the police station north—south corridor is the next opening on the First Avenue facade. East of that door is the rear of the police station section and two windows. A fire escape begins its upward, angular journey toward the 3rd floor of the central, recessed section. The 2nd floor displays 2 window bays each containing three 9 dimensional windows with upper dimension paneled as elsewhere in the building. A single rectangular window with three dimensions or panes occupies a spot at the west end of the recessed section. The 3rd floor has the same window spacing & sizes as the 2nd floor with the exception of the most westerly single window of the 2nd floor recessed area.

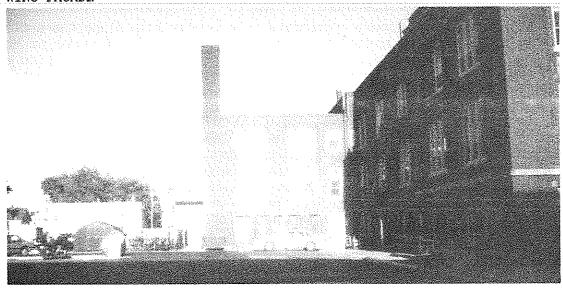
#### NORTH WING FACADE

From the parking lot a west side door permits entry to interior offices of the North Wing. Along the west side of the North Wing three small 2' x 1' windows and one large window help light up the interior. On that wing's 2nd floor are two window groupings each containing 3 rectangular, 6 dimensional windows. The 2 upper panes in each window are blocked by panels. A narrower 3 dimensional window is located above the 1st floor door and the concrete belt course that separates the 2 floors. The 3rd floor repeats the 2nd floor window spacing except that 3rd floor windows are completely intact with no panel blocks on the upper panes. Darker brick strips frame the 2nd and 3rd floor windows and thus focus attention to those window areas. Two design units emerge between the 2nd and 3rd floors over all wing windows. There are no visible concrete belt courses between the 2nd and 3rd floors and from the 3rd floor to the roof. A tall chimney looms in the vicinity of the corner where west and north sides of this wing meet. The north end of that wing is windowless. Its roof is several feet below that of the main Lincoln street building. The X design, rather than the H design, is used within the central circle. Antenna wires streak skyward at the intersection of the North Wing and the east end of the Lincoln Street building. On the Washington Street side of the North Wing only 3rd floor windows and a few 2nd floor windows can be seen because the adjoining fire department addition of 1982 blocks the view.

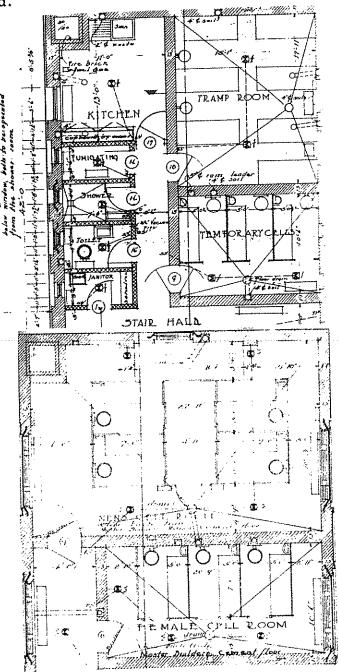
Accessible by stairs leading up from the lower level and down to the ground floor below, the northern wing's 2nd floor housed segregated cells; the female cell room was 20'x10'6", was closest to the stair hall and held 3 cells. Down a 6'wide corridor from the stair hall, past the female cell room was a door to the Men's Cell Room, 18'3" long, at the north end of that wing. Six cells with capability of handling 8 men awaited prisoners. On Thurs. Sept. 24, 1914 ten prisoners were transferred from the old city jail to the new building. Escorted by Chief G.W. Hurst, Jim Limboe of Aberdeen was the first man to be confined in the new jail. One prisoner told a reporter: "This certainly is swell doin's, but, do you know, I'd rather be outside."

The top floor of the North Wing held facilities for prisoners awaiting trial in the nearby 3rd floor courtroom. North of stairs the and the main building's courtroom was a police matron's room with toilet and bathroom as well as 4 men's cells accomodating 8 men who could be brought to the nearby courtroom through the hallway. The floor plan was much like that of the second floor. Upon entering the stair hall one entered the Matron's room. 10'6" long and 20'9" wide. Further northward down the corridor an iron stairs led to the roof. Nearby at the northern most part of that wing the men's cell room stretched northward 18'3" and west to east about 26'. The room contained 4 cells each 7' wide.

Based on the architectural plans of Herges, Kirkgasler and Associates of 1972, the police department lost all 3rd floor space in the North Extension. Contractors installed a new floor system. Windows on both west and east sides were replaced. In that North Wing the Municipal Court gained former jail cell space to provide room for a jury/meeting room, a waiting room and a room for court clerks. The former Matron's room became a jury/meeting room 10'4"x20'6". Northward along a corridor and behind the jury room the former men's cell area

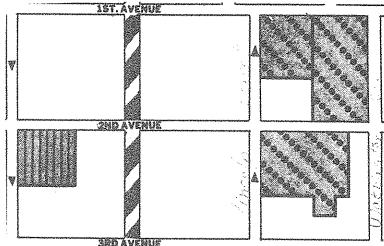
Paved parking lots and street parking permit motorists to be within reasonable walking distance to the municipal building. Between First Avenue SE to the north and the city hall corner is one sizeable lot shared with Brown County and across 2d Avenue to the south is another large lot in addition to street parking along Second Avenue & Lincoln Streets. In 1978 when Main Street was under construction, parking lots on Lincoln Street around City Hall were improved. Until 1981-82 the space now occupied by the fire department was used for parking as illustrated in the sketch below.

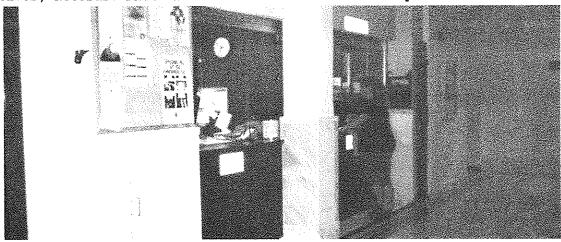
Until recent renovations the 1st, 2nd and 3rd floor west-east corridors were centrally located with offices and service counters flanking the north and south sides of each corridor. Today there are 3 public service counters along the 1st floor—a finance dept. counter to pay water bills and 2 counters inside office doors—1 in the finance office near the Lincoln Street entrance and 1 in the auditor's office at the corridor's east—end. Before 1990s renovations the auditor's service counter opened on the south side of 2nd floor. After a 1978 remodeling of the 2nd floor the former Girl Scout Room provided a corridor leading to the 2nd floor north wing. In 1996 the door to this corridor reads: Detectives, Records. Photo below of 1st floor Finance Dept. service counter.
